Second Five-Year Review Report

FMC YAKIMA

Superfund Site
Yakima, Washington

SEPTEMBER 2003

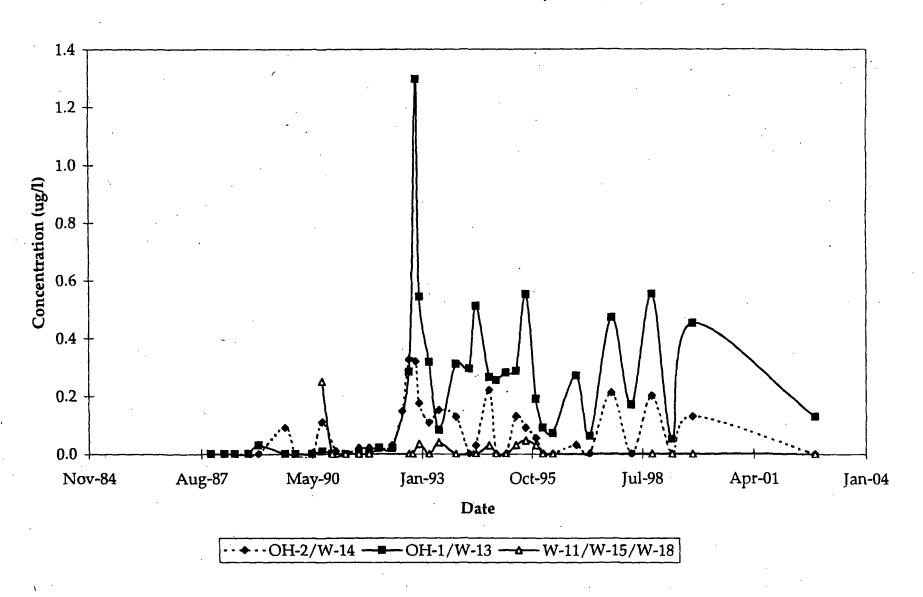
Figure 4-2
Concentration of Aldrin plus Dieldrin in Selected Wells

The most recent monitoring report dated January 2003 was conducted in the fall of 2002 by the PRP contractor, EMR inc. Residual pesticide contamination continues to be detected in site ground water sample at very low levels and their values appear to be decreasing or are stable with time. Dieldrin was detected in wells W-12A, W-13, and W-!7 at 0.064, 0.25 and 0.054 ug/l respectively. DDT was not detected above the PQL. The PQL for all the listed chemicals was 0.05ug/l other than tedion which was 0.1ug/l. The highest value for total endosulfans was observed at well W-18 at 1.35 ug/l. Tables 2-1 contain the summary of Detections and individual well result from the 2002 sampling event. Figure 4-2 shows the concentrations of selected well of Aldrin plus Dieldrin over time, while Figure 4-3 shows the total Endosulfans in selected well over time. Figures include the 2002 sampling event.
